DEPARTMENT OF TRANSPORTATION**DIVISION OF ENGINEERING SERVICES**

Contract #: 04-0120F4Cty: SF/ALA Rte: 80 PM: 13.2/13.9File #: 69.28**WELDING INSPECTION REPORT****Resident Engineer:**Pursell, Gary**Address:** 333 Burma Road**City:** Oakland, CA 94607**Report No:** WIR-002725**Date Inspected:** 30-May-2008**Project Name:** SAS Superstructure**OSM Arrival Time:** 630**Prime Contractor:** American Bridge/Fluor Enterprises, a JV**OSM Departure Time:** 1530**Contractor:** Zhenhua Port Machinery Company, Ltd (ZPMC), Changxing Island **Location:** Shanghai, China**CWI Name:** Shazhi and Zhang Bao Lei**CWI Present:** Yes No**Inspected CWI report:** Yes No N/A**Rod Oven in Use:** Yes No N/A**Electrode to specification:** Yes No N/A**Weld Procedures Followed:** Yes No N/A**Qualified Welders:** Yes No N/A**Verified Joint Fit-up:** Yes No N/A**Approved Drawings:** Yes No N/A**Approved WPS:** Yes No N/A**Delayed / Cancelled:** Yes No N/A**Bridge No:** 34-0006**Component:** OBG and SAS Tower Fabrication**Summary of Items Observed:**

WELDING INSPECTION REPORT

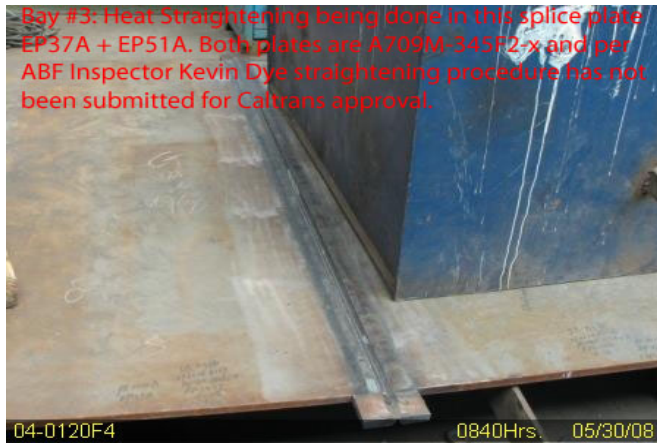
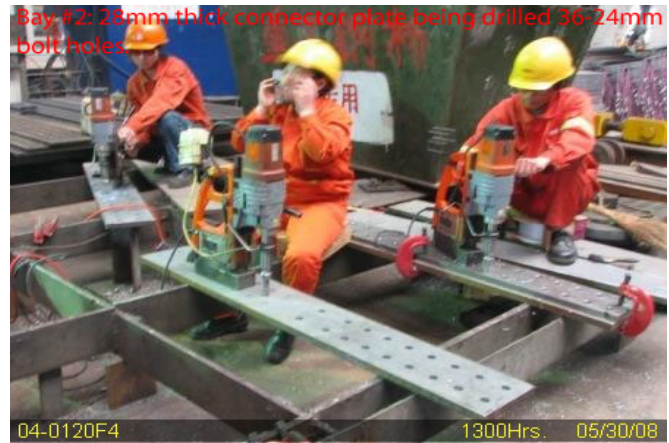
Other related welding activities observed were bevel cutting on bent heavy plates for tower diaphragm rings and tack welding/fit up of stiffener to web plates on various longitudinal diaphragms.
